ILLINOIS MINERALS NOTE 72
May 1979

ROOF STRATA OF THE HERRIN (NO. 6) COAL MEMBER IN MINES OF ILLINOIS: THEIR GEOLOGY AND STABILITY

Summary report

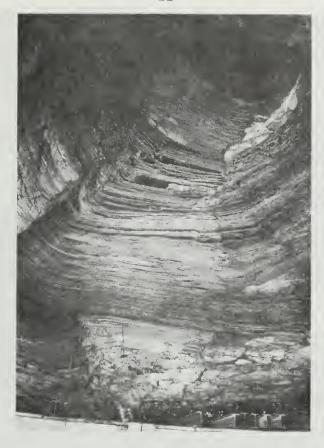
Location: "Quality Circle," near Walshville channel, mine C.

Figure 6. Roof fall in planar-bedded sandstone of the Energy Shale Member. Bedding surfaces are coated with mica and coalified plant fragments. No prominent joints are visible. Sandstone failed and broke almost straight up along the pillar rib.

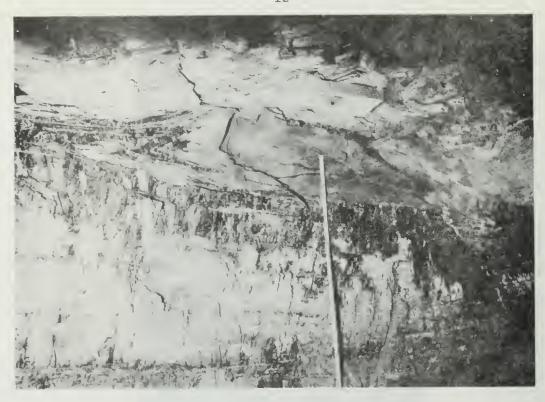
Figure 8. Roll of medium-gray shale of the Energy Shale Member intruded into top layers of the Herrin (No. 6) Coal. Toe (at the left) splits folded coal strata into several stringers. Tail has been truncated by compactional normal fault (at the right). The rod is about 4 feet (1.2 m) long. Location: "Quality Circle."

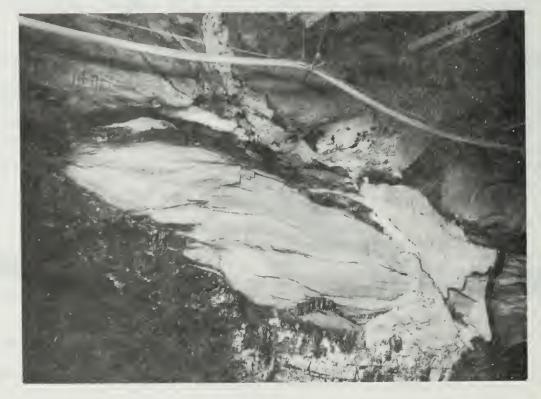
Figure 9. Large roll (10 feet [3 m] wide) of siltstone material. The toe of the roll displays slight soft-sediment deformation. Coal "rider" extends over two-thirds of the roll. Location: "Quality Circle," southern Illinois, mine C.

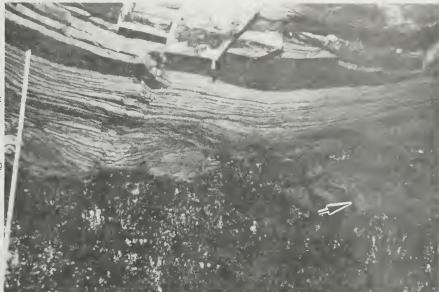
Figure 10. Roll in planar-bedded siltstone and sandstone of the Energy Shale Member. Near the toe of the roll (arrow), recumbent softsediment folds and lowangle shear planes are visible. These features suggest that the silt and sand filling the roll intruded from right to left between the layers of peat. (Note the coal "rider" originating at the toe and extending almost entirely over the roll.) The large low-angle slips at the tail of the rolls may have formed later by

differential compaction.

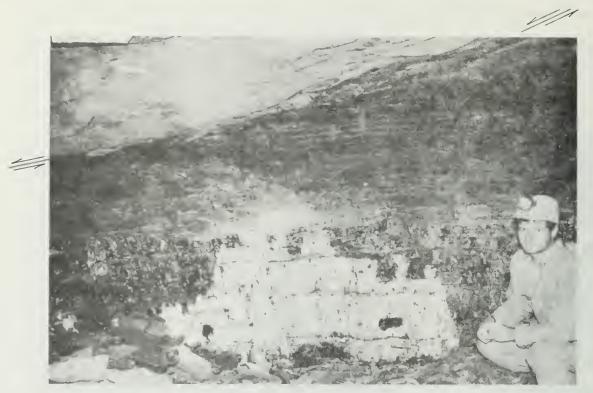
Figure 17. Almost undisturbed Herrin (No. 6) Coal and some beds of finely laminated silty shale truncated by a northward-dipping (to the left) set of major shear surfaces and overlain by the shear body. Location: southern Illinois, "Quality Circle," study area 5, mine B.

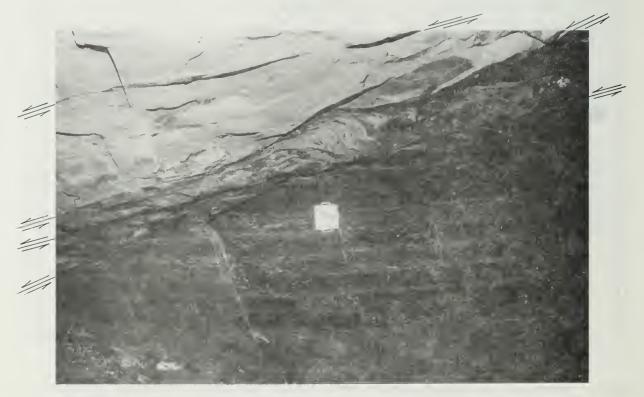
Figure 18. Detail of figure 17—major shear surfaces, a set of very low-angle normal faults bordering the shear body (light rock, upper part of photo) and truncating finely laminated shale below. Note the associated drag folds (soft-sediment folds above compass) within the shear zone.

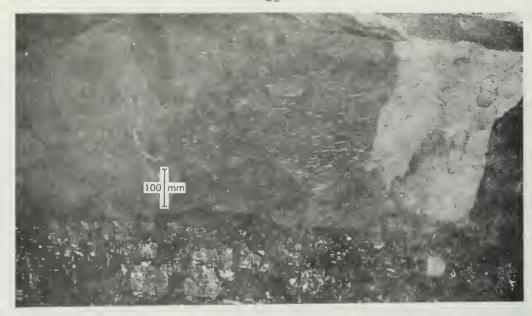
Figure 20. Microfaulted laminated silty shale and siltstone. Low-angle and high-angle shear planes are adjacent and are of a single deformational action. The microfault pattern resembles the lower portion of seismites described by Seilacher (1969).

Major shear plane is subparallel to bedding just above coal. Coal itself is affected only at extreme top. Location: southern Illinois, "Quality Circle," study area 5, mine B.

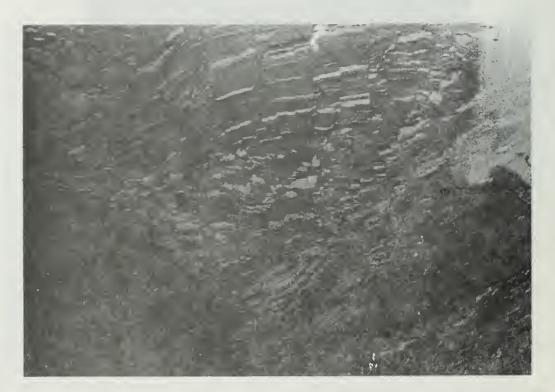
Figure 21. Detail of figure 20.

Mass movement in general is downward, and each lower portion has moved laterally toward the south (left in photo).

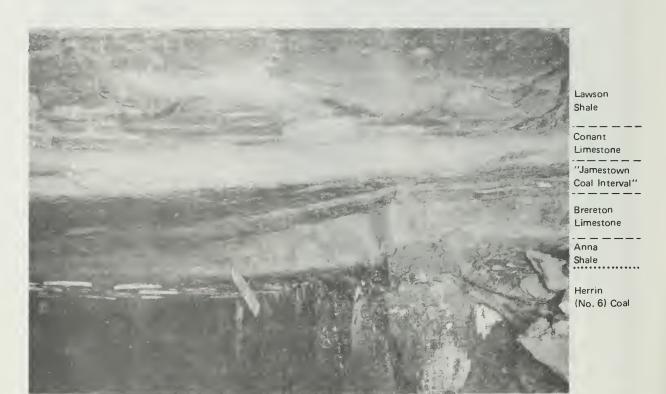
Figure 27. Wedging relationship of rook layers; both the Anna Shale and the Brereton Limestone pinch out (toward left side of photo). The "Jamestown Coal interval" has thin coal streaks and contributes to bedding separation. The overlying Conant Limestone is too thin to bridge stresses from one pillar to the next. The Lawson Shale is soft and mottled and contains numerous low-angle shear planes and syneresis cracks. Location: mine A, west-central Illinois.

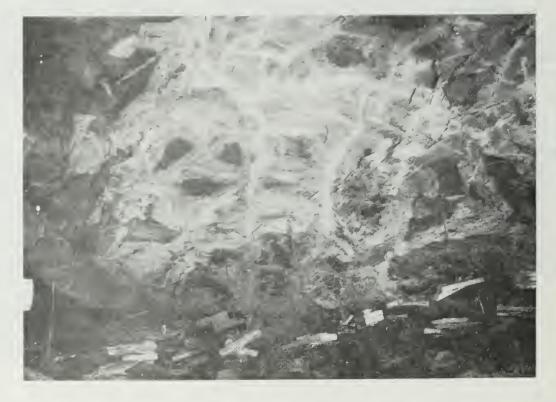
Figure 29 Mottled shale with syneresis cracks in greenish medium-gray shale, above very dark gray shale, probably Lawson Sh (with syneresis cracks) above Anna Shale. Note roof bolts hang out bare; the soft shales have fallen because of mois slaking; in the center of roof fall, even bolt anchors have fallen out. Location: a mine in east-central Illinois.

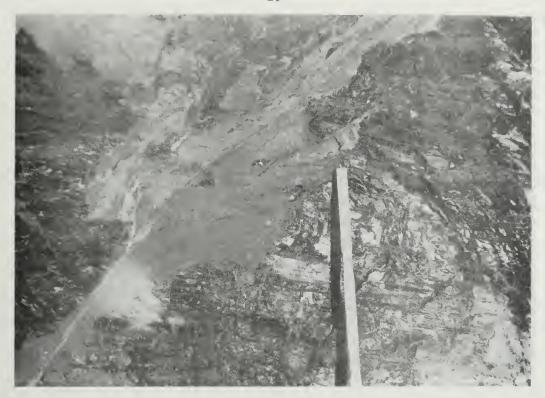
Figure 30. Clay dike and clay-dike fault in Herrin (No. 6) Coal. Angular fragments of unaltered and altered black shale from the roof and of coal in the clay matrix demonstrate the brittle behavior of the material during deformation. Synthetic and antithetic minor faults are displayed. Note also the plastic behavior of coal, particularly at the end of the small clay intrusion upward, in the upper footwall block. Displayed there is a convergence structure of the coal laminae. Location: mine A, west-central Illinois.

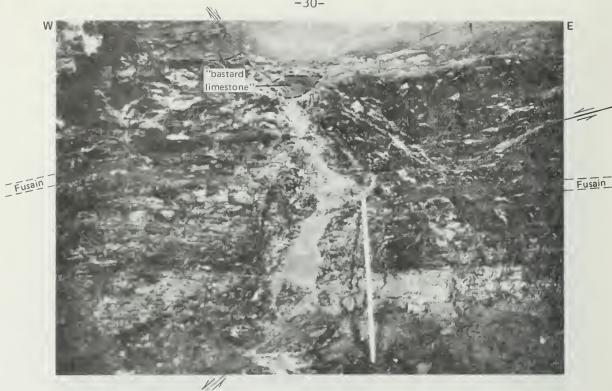
Complex clay dike in the Herrin (No. 6) Coal. Roof is Brereton Limestone, which is displaced downward to the east, Figure 32. Fusain layer in the center of the coal seam is bent downward east of clay dike, fractured within the clay dike, and offset immediately west of the dike. Note the associated small low-angle clay-dike faults and the numerous extension fractures ("goat beards") and the coal fragments in the clay matrix.

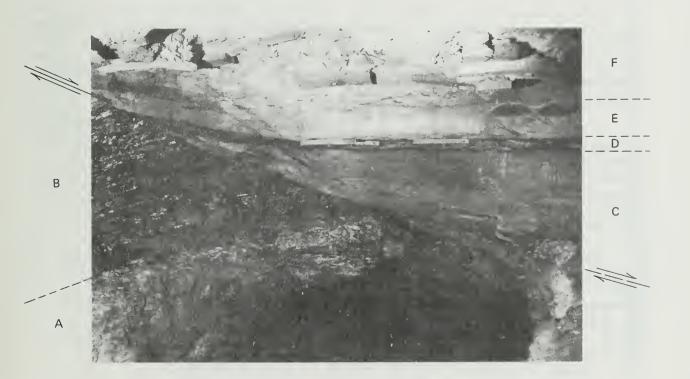
Figure 41. Clay-dike fault, Low-angle normal fault (dip angle 35° to 50°) with more than twelve feet (3.6 m) of throw (on figure 35, area A/9 to D/7). Shales, calcareous strata, and lower portion of Herrin (No. 6) Coal show normal drag, whereas upper portion of the coal diplays false drag. Strata from the underclay of Springfield (No. 5) Coal up to the Bankston Fork Limestone are truncated. Photo shows: A—underclay, B—Herrin (No. 6) Coal; C—Brereton Limestone; D—"Jamestown Coal interval"; E—Conant Limestone; and F—Lawson Shale. Location: study area 1, mine A, west-central Illinois.
